Manhole Inspection Summary

Manhole # S45W__014MH

Insp Date: **3/5/08 11:52 AM**

Location Address: **1310 andre**

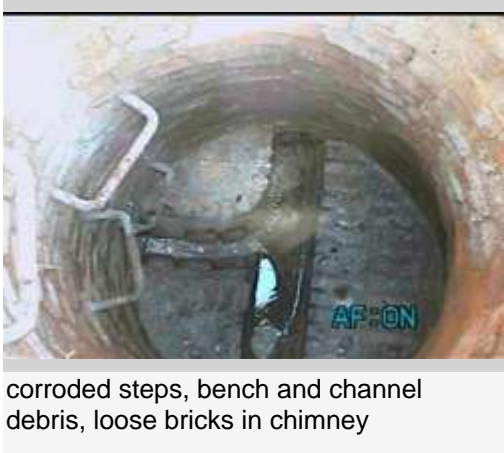
Defect 1

Steps Count: **4** Missing: **0** ☒ **Corroded**

corroded steps, bench and channel
debris, loose bricks in chimney

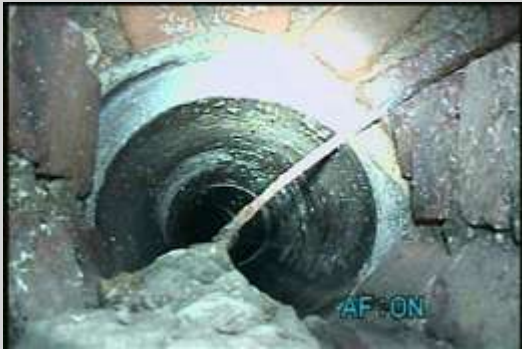
12 O'Clock Outflow

8 in. Circular Gravity Sewer
Pipe Out @ 12 O'Clock

Pipe Material: **Clay** ☐ Pipe Lined

Invert Depth: **8.50** (ft.) Flow Characteristics: **Slow**

Deposits: ☒ None ☐ Mud ☐ Sludge ☐ Debris ☐ Grease

Infiltration: **None** Pipe Seal Cond: **Unknown**

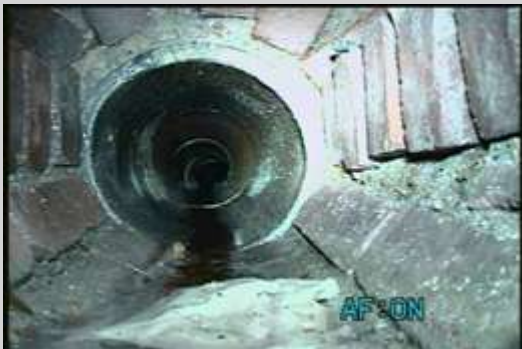
6 O'Clock Inflow

8 in. Circular Gravity Sewer
Pipe In @ 6 O'Clock

Pipe Material: **Clay** ☐ Pipe Lined

Invert Depth: **8.20** (ft.) Flow Characteristics: **Slow**

Deposits: ☒ None ☐ Mud ☐ Sludge ☐ Debris ☐ Grease

Infiltration: **None** Pipe Seal Cond: **Unknown**

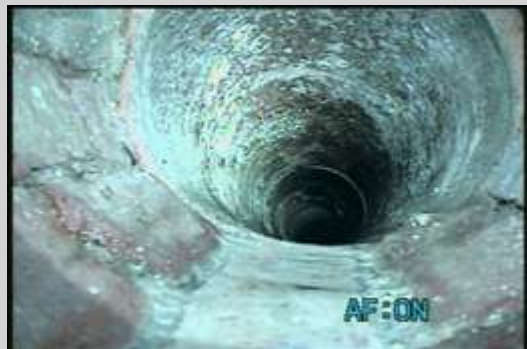
9 O'Clock Inflow

8 in. Circular Gravity Sewer

Pipe In @ 9 O'Clock

Pipe Material: **Clay** ☐ Pipe Lined

Invert Depth: **8.00** (ft.) Flow Characteristics: **Slow**

Deposits: ☒ None ☐ Mud ☐ Sludge ☐ Debris ☐ Grease

Infiltration: **None** Pipe Seal Cond: **Unknown**
